Inspection Field Notes for Former Plastech-Andover Facility

Facility&Address: Former Plastech Engineered Products, Inc.-Andover
205 Maple Street Extension
Andover, OH 44003
ID number: OHD068896778
Inspector: Frank Zingales (FZ)
Date: 4-26-10
Time: 0955-1115
Facility Rep: Duane Smith (DS) – Trusted Partners
Purpose of Inspection: Compliance evaluation inspection
Sample(s) Taken: No
Photograph(s) Taken: Yes

Former Plastech Andover Facility
205 Maple St. Ext.
Andover, OH 44003

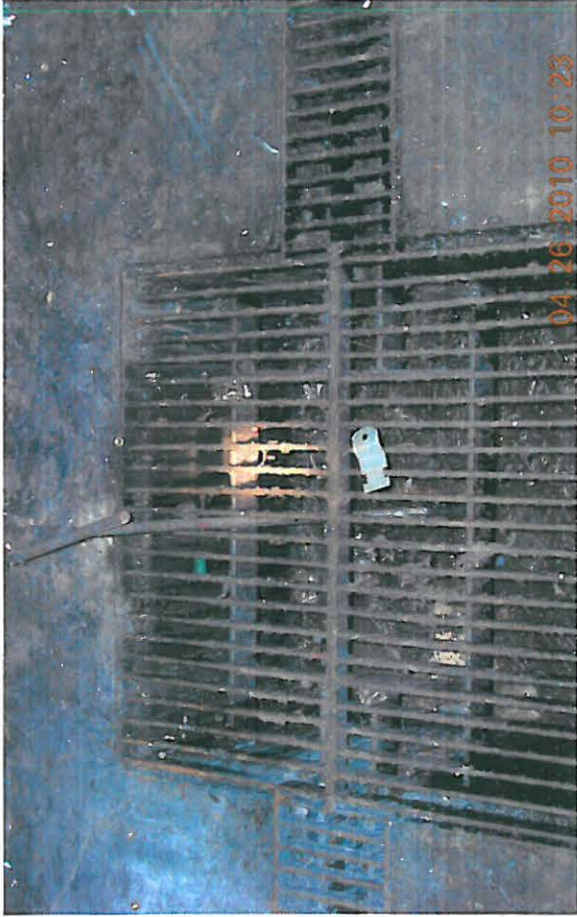
Photograph #1

- Paint related waste present in trench drains and sumps. Noted two sumps, each approximately 30" X 30" with 12" and 4"-6" of paint waste, respectively, in bottom.
- No containers present in former hazardous waste accumulation area.

Ohio EPA Photograph Log Former Plastech-Andover Facility April 26, 2010 All digital photographs taken and logged by Frank Zingales. DHWM Digital Camera #5 - Nikon Coolpix 5600		
Photo #	Area	Description
1&2	Interior, North Paint Kitchen	Sump with approximately 12" of paint waste in bottom.
3-5	Exterior, South/Southeast	3 compressed gas cylinders (propane).
6-8	Exterior, South/Southeast	View of wood pallets, plastic packaging and solid waste.
9-11	Exterior, Southwest side	3 transformers and label info.
12	Exterior, Southwest side	Compressed gas cylinder.
13-17	Exterior, North side	View of area where air abatement system was removed from. Waste present in vents.
18&19	Exterior, West side	View of front of facility.

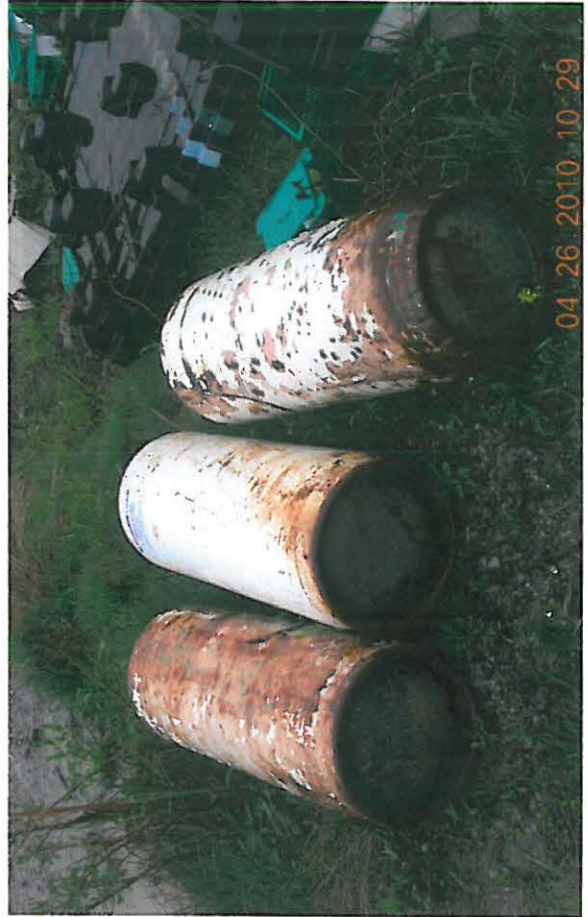
Photograph #3

- 3 compressed gas cylinders (propane). Label info: property of AmeriGas-Ashtabula.
- Wood pallets, plastic packaging and solid waste present.
- 3 transformers (numbers 91780, 91781 and 91782). Label indicated PCB content <50 ppm.

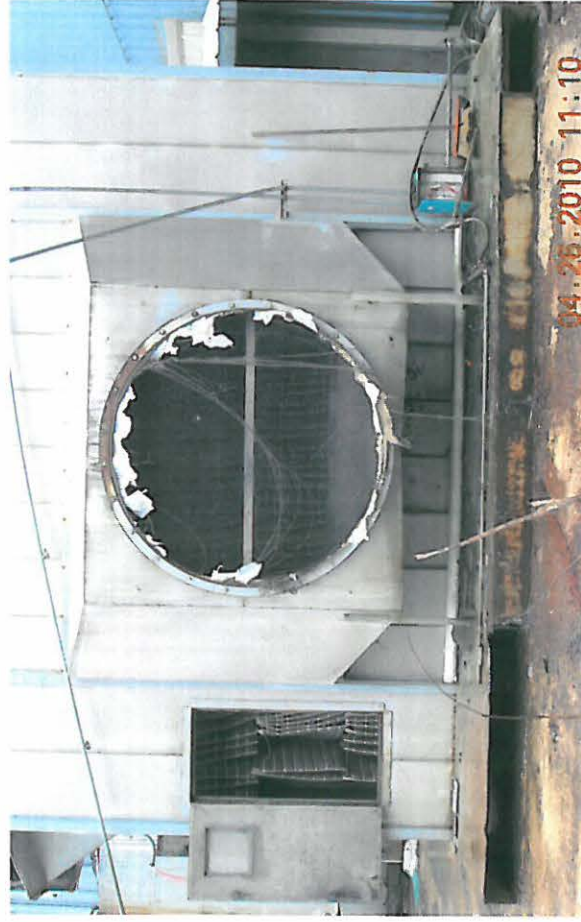
Photograph #16

- Purchased and removed by paint equipment contractor.
- Waste present in exhaust vents and filter media.
- 2, 5-gallon containers of compressor fluid.
